Subject: Inspection, certification, and calculations of trees to satisfy the Nassau County Tree ordinance requirements for the new proposed Enclave Beach Access from Enclave I to Amelia Island Parkway

ENCLAVE AT SUMMER BEACH HOA

PROJECT NAME PHASE 1 ORANGE AVENUE PATH

ARBORIST REPORT TREE PROTECTION DETAIL / NOTES SHEET NO.

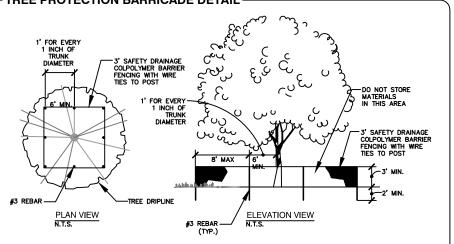
TREE PROTECTION BARRICADE DETAIL

THE TREE PROTECTION BARRICADE SHALL BE AT LEAST THREE (3) FEET HIGH. THE BARRIER SHALL CONSIST OF EITHER WOOD FENCE WITH 2x4 POSTS PLACED A MAXIUM OF EIGHT (8) FEET APART, WITH A 2x4 TOP RAIL OR A TEMPORARY WIRE MESH FENCE, OR OTHER SMILAR BARRIER WHICH WILL LIMIT ACCESS TO PROTECTED AREA.

THE BARRIER SHALL BE AT LEAST ONE FOOT IN DIAMETER FOR EVERY INCH OF TRUNK DIAMETER. FOR TREES LESS THAN 12" DBH, THE MINIMUM BARRIER SHALL BE AT LEAST SIX (6) FEET AWAY FROM THE BASE OF THE TREE.
