South Amelia Island Shore Stabilization Project

HURRICANE IRMA (FEMA DR-4337) POST-STORM DESIGN SURVEY & ANALYSIS

February 2018
(Revised August 2018)

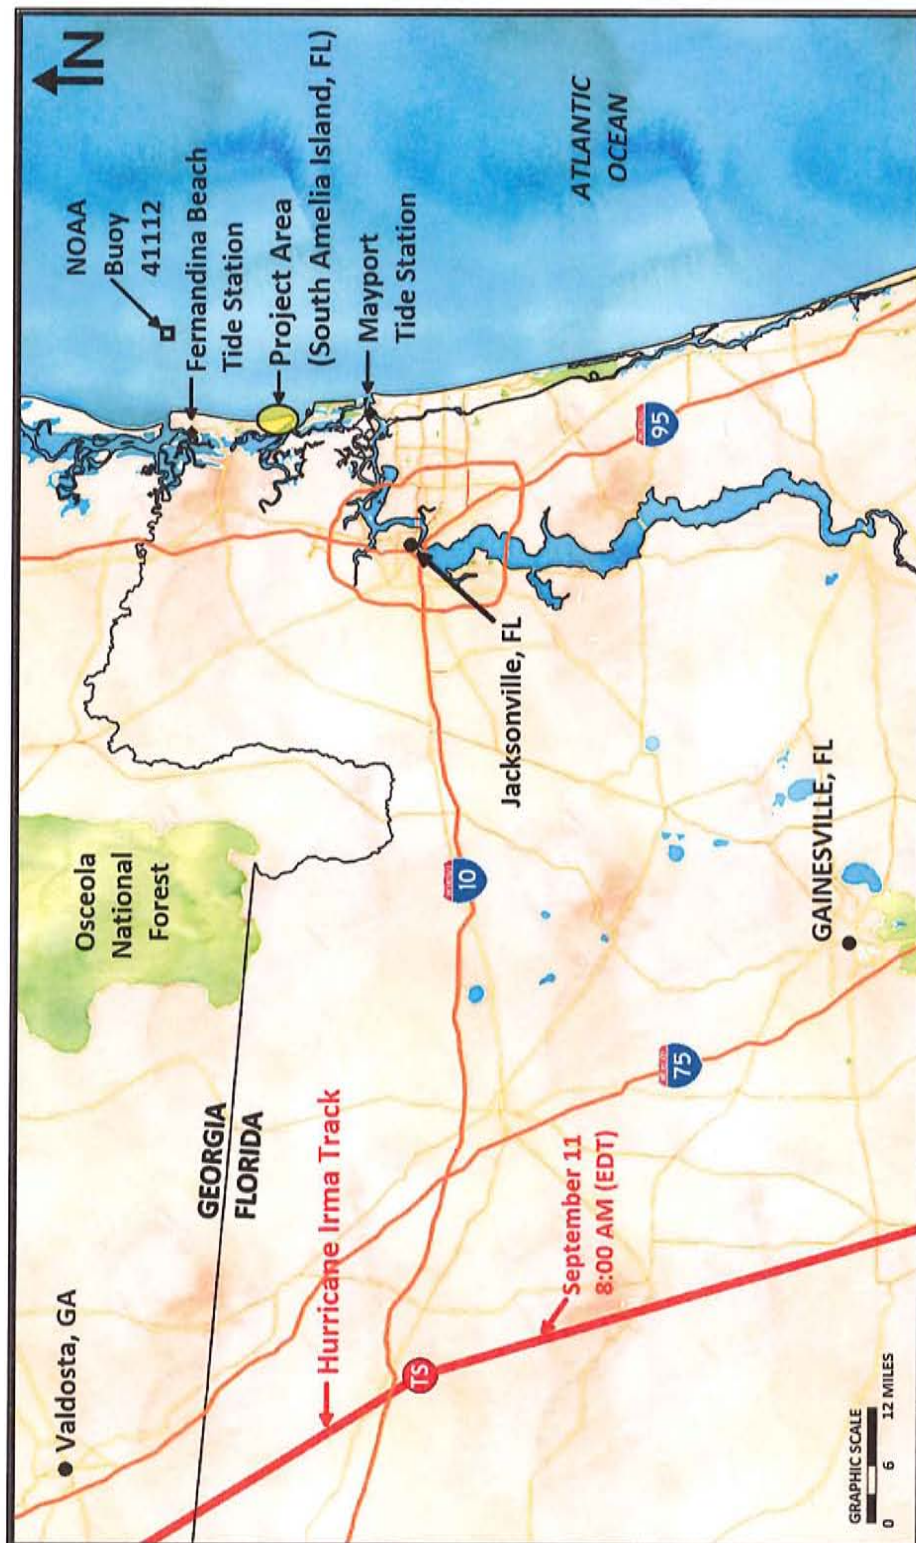
Figure 2.2 plots the track of the storm in the vicinity of Amelia Island. The figure also displays the location of NOAA Buoy 41112, located roughly 8 miles offshore of Fernandina Beach, FL, approximately 16 miles northeast of the project. The buoy was deployed in February 2006 in roughly 50 feet of water and been collecting data nearly continuously for 12+ years. The data collected by the buoy include significant wave height (average of the highest one-third of all waves in a 20-minute sampling period), wave period, wave direction, water temperature and other standard meteorological data.

Additionally, **Figure 2.2** shows the locations of the Mayport (NOS 8720218) and Fernandina Beach (NOS 8720030) tidal stations, owned and maintained by NOAA's National Ocean Service (NOS) Water Level Observation Network. The Mayport station is located within the mouth of the St. John's River approximately 8 miles south of the project area. The Fernandina Beach station is located on the Amelia River, approximately 10 miles north of the project area. Both stations typically collect readings of water level, wind speed, gust speed, atmospheric pressure, and other meteorological data. It is noted that both tide gages are not located on the open coast but in sheltered areas. As such, water levels reported here are likely to be somewhat lower than those experienced along the open coastline of Amelia Island.

Figure 2.2: Storm track of Hurricane Irma in the vicinity of Amelia Island showing the location of NOAA Buoy 41112 and nearby tide stations. (Track available from the National Hurricane Center).

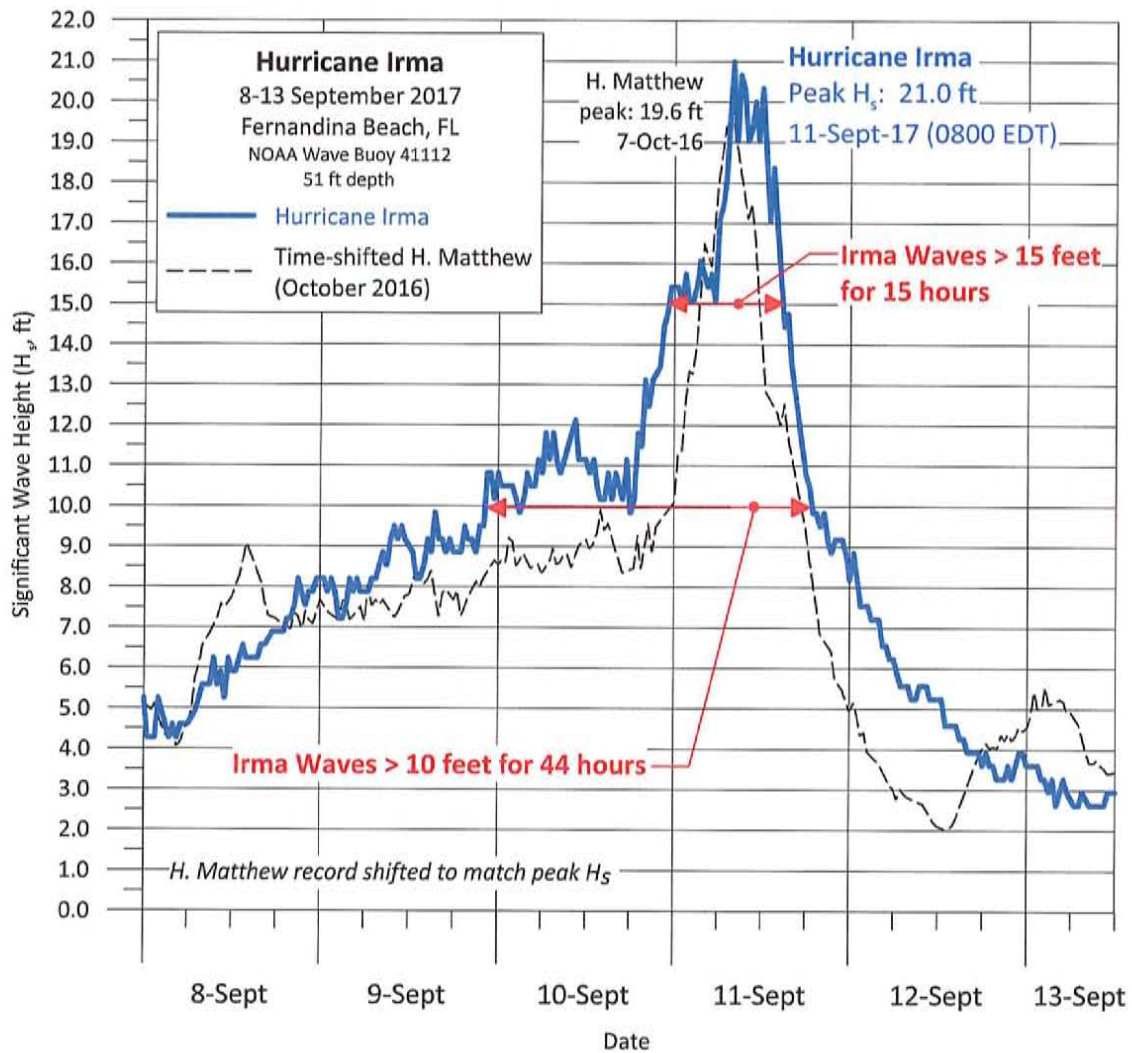
Wave Heights Figure 2.3 displays the time series of significant wave heights measured at NOAA Buoy 41112 as Hurricane Irma approached and passed Amelia Island. While the buoy is located offshore in unprotected waters, the wave conditions measured can generally be related to nearshore conditions along the project limits. All wave statistics mentioned in this section will be from measurements at Buoy 41112.

Figure 2.3: Time series of significant wave heights measured at NOAA Buoy 41112 during the passage of Hurricane Irma in September 2017. The buoy is located approximately 16 miles northeast of the south Amelia Island shoreline in 51 feet of water.

The largest recorded significant wave height⁴ in Irma was measured to be 21.0 ft. The dominant wave period peaked at about 13 seconds during this time. Waves exceeding 10 ft persisted for over 44 hours, and waves exceeding 15 ft persisted for more than 15 hours. For comparison, the time series of Hurricane Matthew in October 2016 is plotted in time-shifted fashion in **Figure 2.3**. While the peak wave height in Matthew was similar at 19.6 ft, the duration of large waves, and hence the total energy striking the beach in the storm, was noticeably greater in Irma. In Matthew, waves exceeding 10 ft in height only persisted for 18 hours (versus 44 hours for Irma).

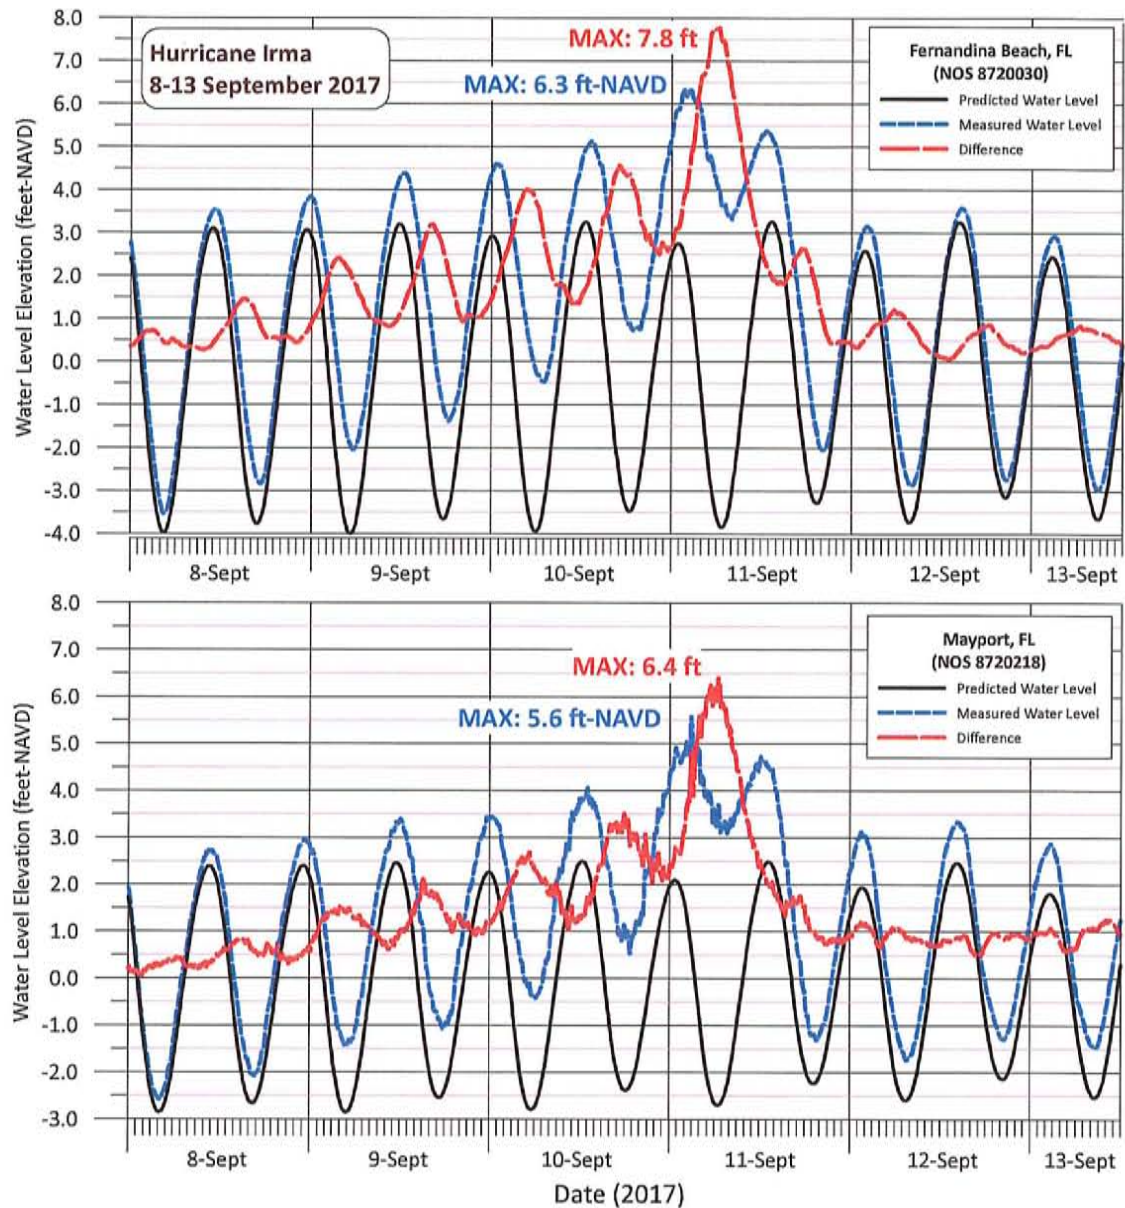
Figure 2.4: Time series of water levels measured at two nearby tide gages located along the northeast Florida coast during the passage of Hurricane Irma. The two stations, Fernandina Beach (NOS: 8720030) and Mayport (NOS: 8720218) are both maintained by NOAA and are within 10 miles of the project area. Neither gage specifically indicates the water levels along the open coast of south Amelia Island.

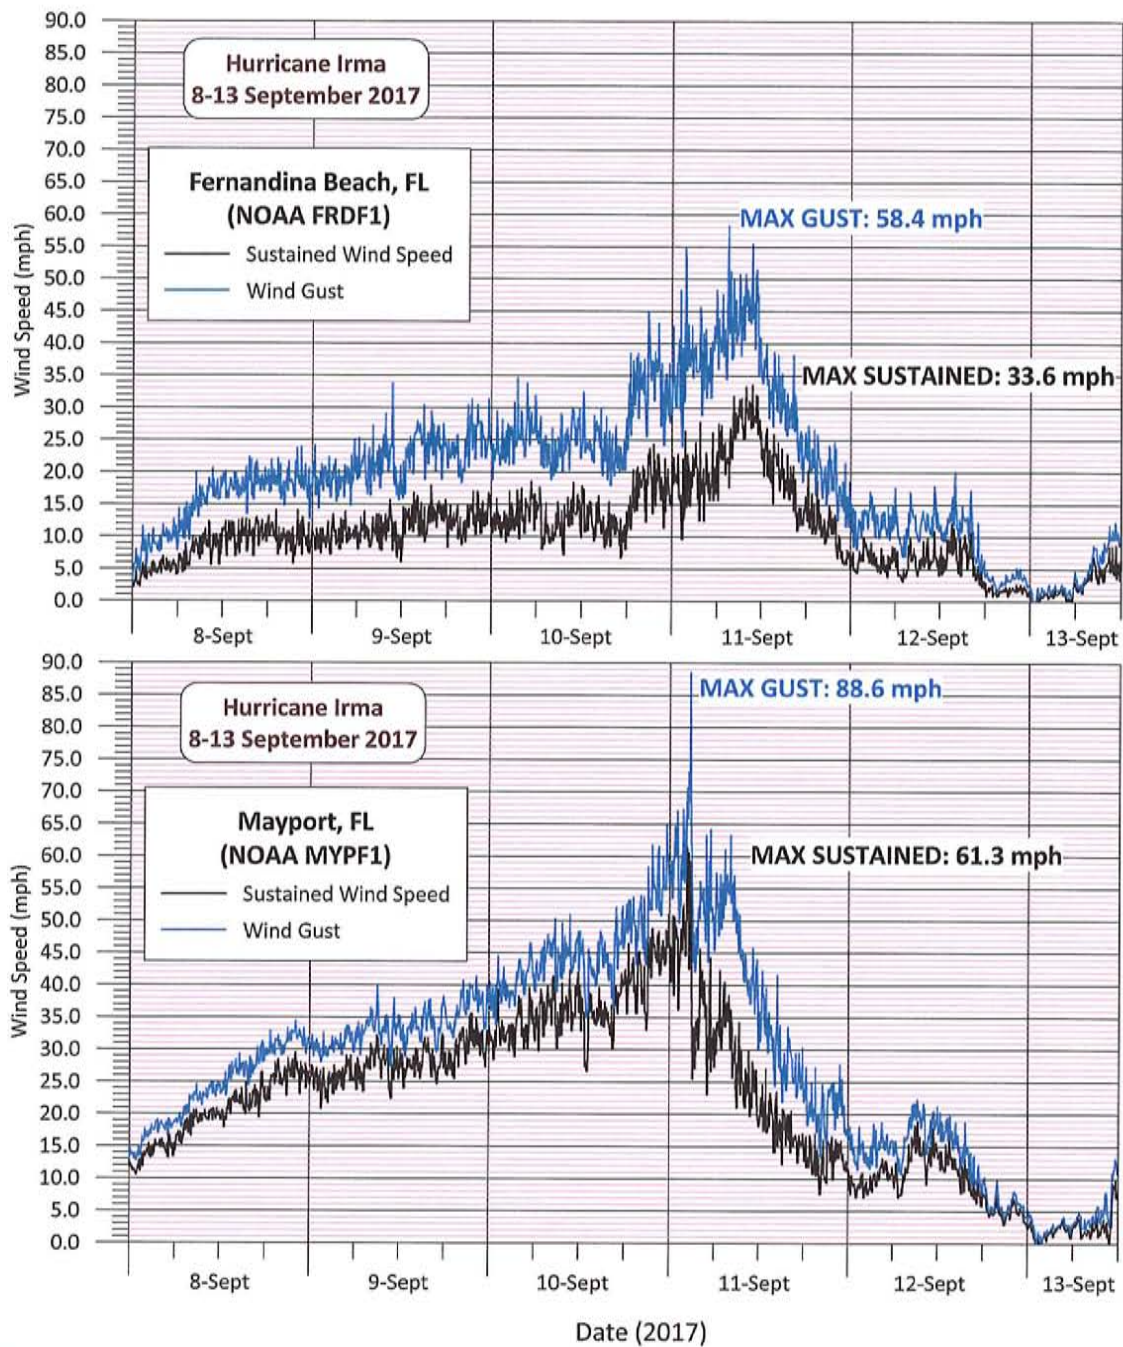
Figure 2.5: Time series of wind speed measured at the Fernandina Beach (FRDF1) and Mayport (MYPF1) stations during the passage of Hurricane Irma.

Fernandina gage was 55.3 mph (tropical storm force). The Fernandina gage is much more sheltered from winds from the east and southeast.

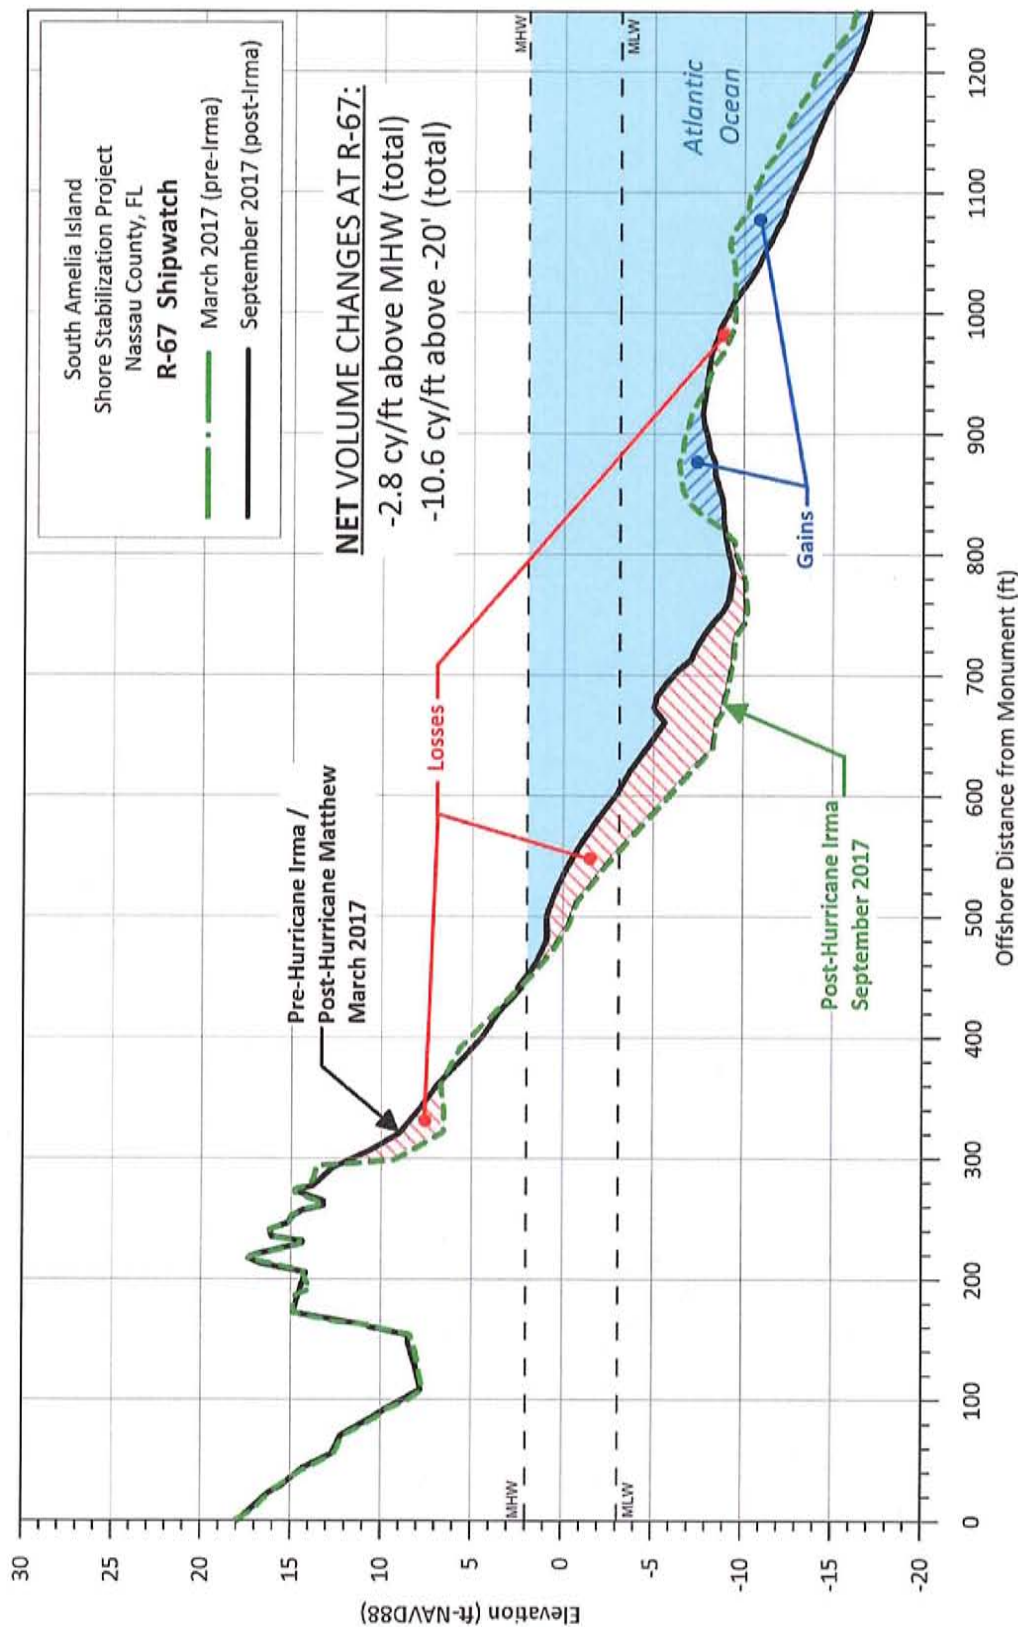
Figure 3.3: Changes in beach profile shape and volume density at R-67 (Shipwatch) associated with the impacts of Hurricane Irma in September 2017.

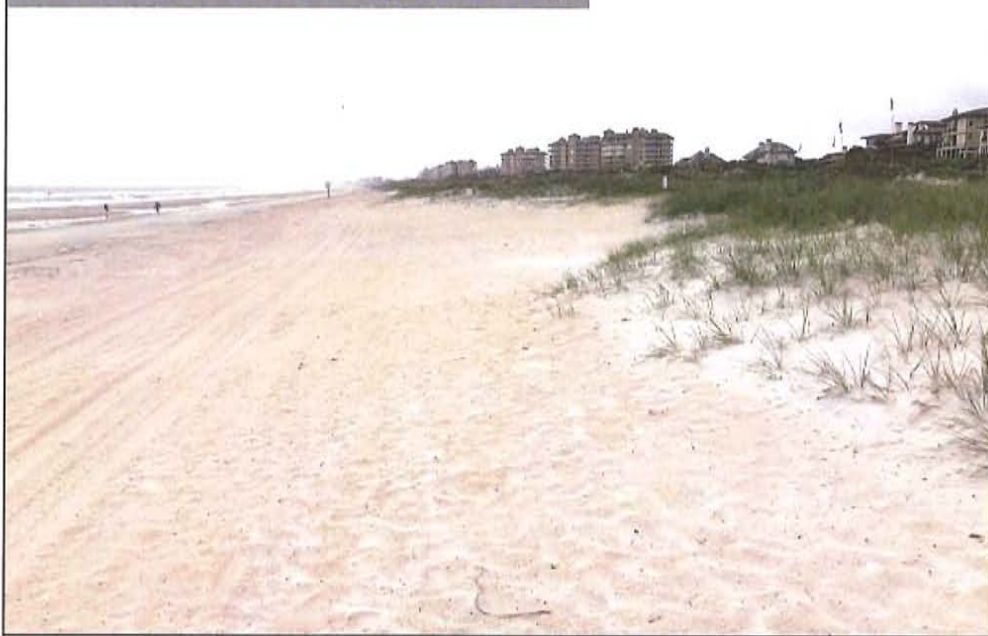
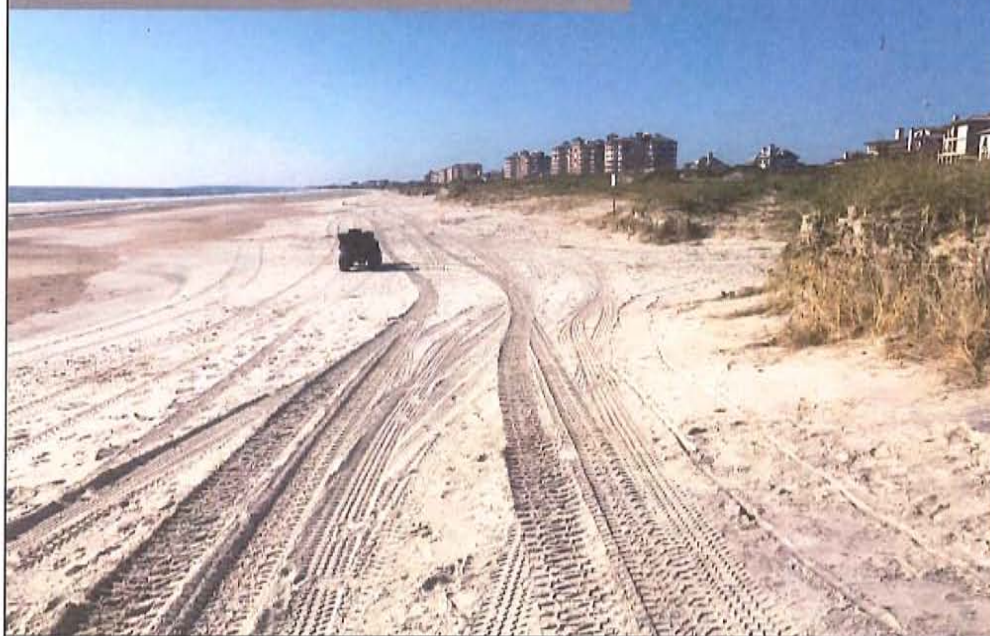
Figures 3.4 through 3.8 depict pre- and post-storm ground photos of the beach conditions associated with Hurricane Irma. The photos illustrate the impacts of the storm upon the upper portions of the engineered fill berm, which suffered damage and erosion during the storm. Notable in **Figures 3.7 and 3.8** is the deflation of the beach berm, evidenced by the loss of pioneer vegetation at the seaward edge of the berm.

Figure 3.4: Pre- and post-Hurricane Irma SAISSP shoreline at the 15th green, looking southward down the 16th fairway toward FDEP survey monument R-60.

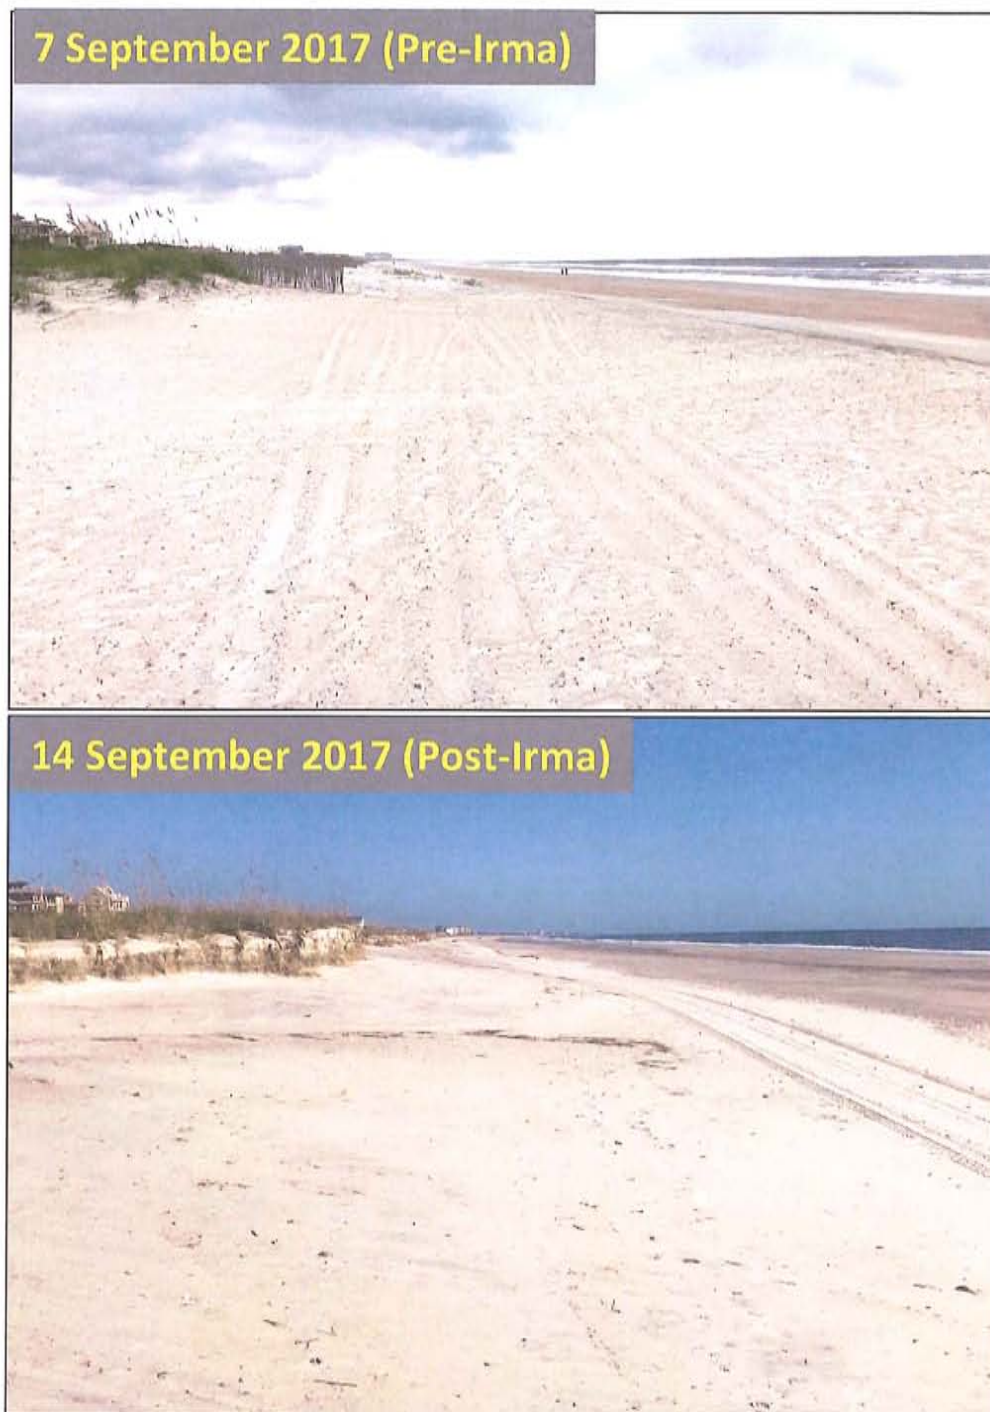
Figure 3.5: Pre- and post-Hurricane Irma SAISSP shoreline at the Ocean Club, looking northward at FDEP survey monument R-61.

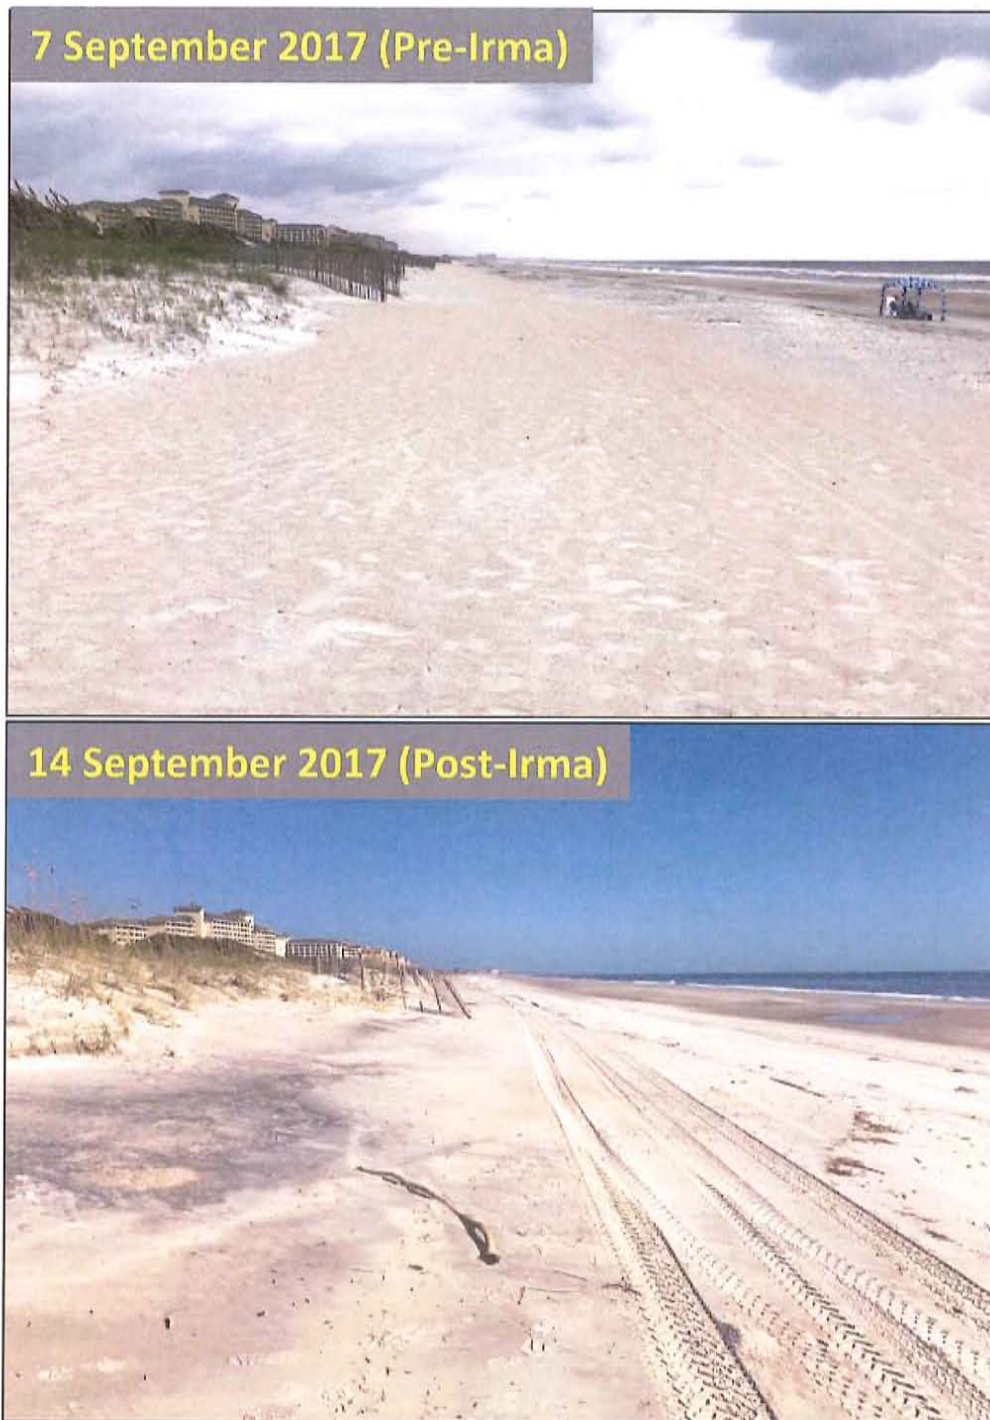
Figure 3.6: Pre- and post-Hurricane Irma SAISSP shoreline at Beach Walker, looking northward at FDEP survey monument R-66.

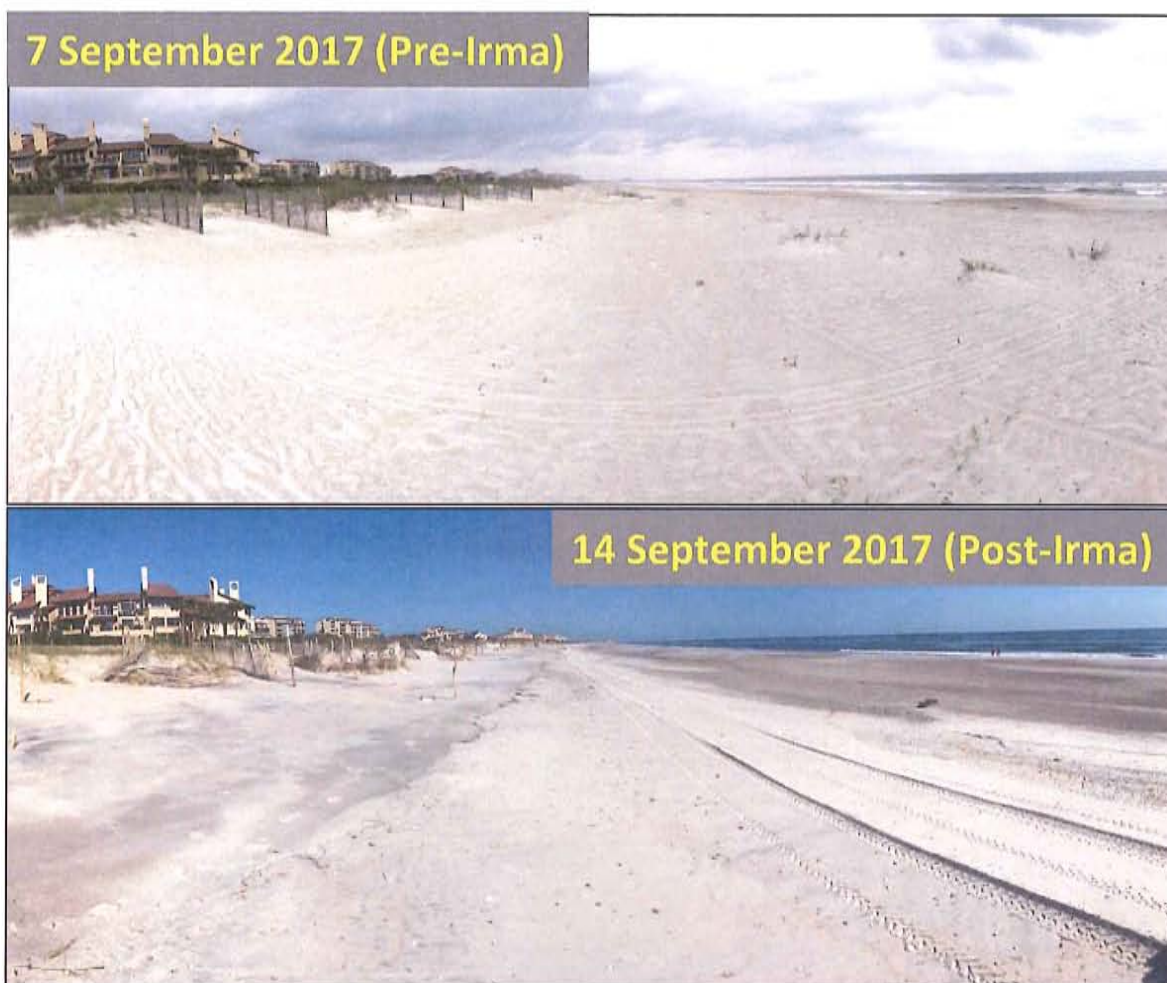
Figure 3.7: Pre- and post-Hurricane Irma SAISSP shoreline at Windsong looking northward at FDEP survey monument R-68. Note the deflation of the beach berm, evidenced by the loss of pioneer vegetation at the seaward edge of the berm.

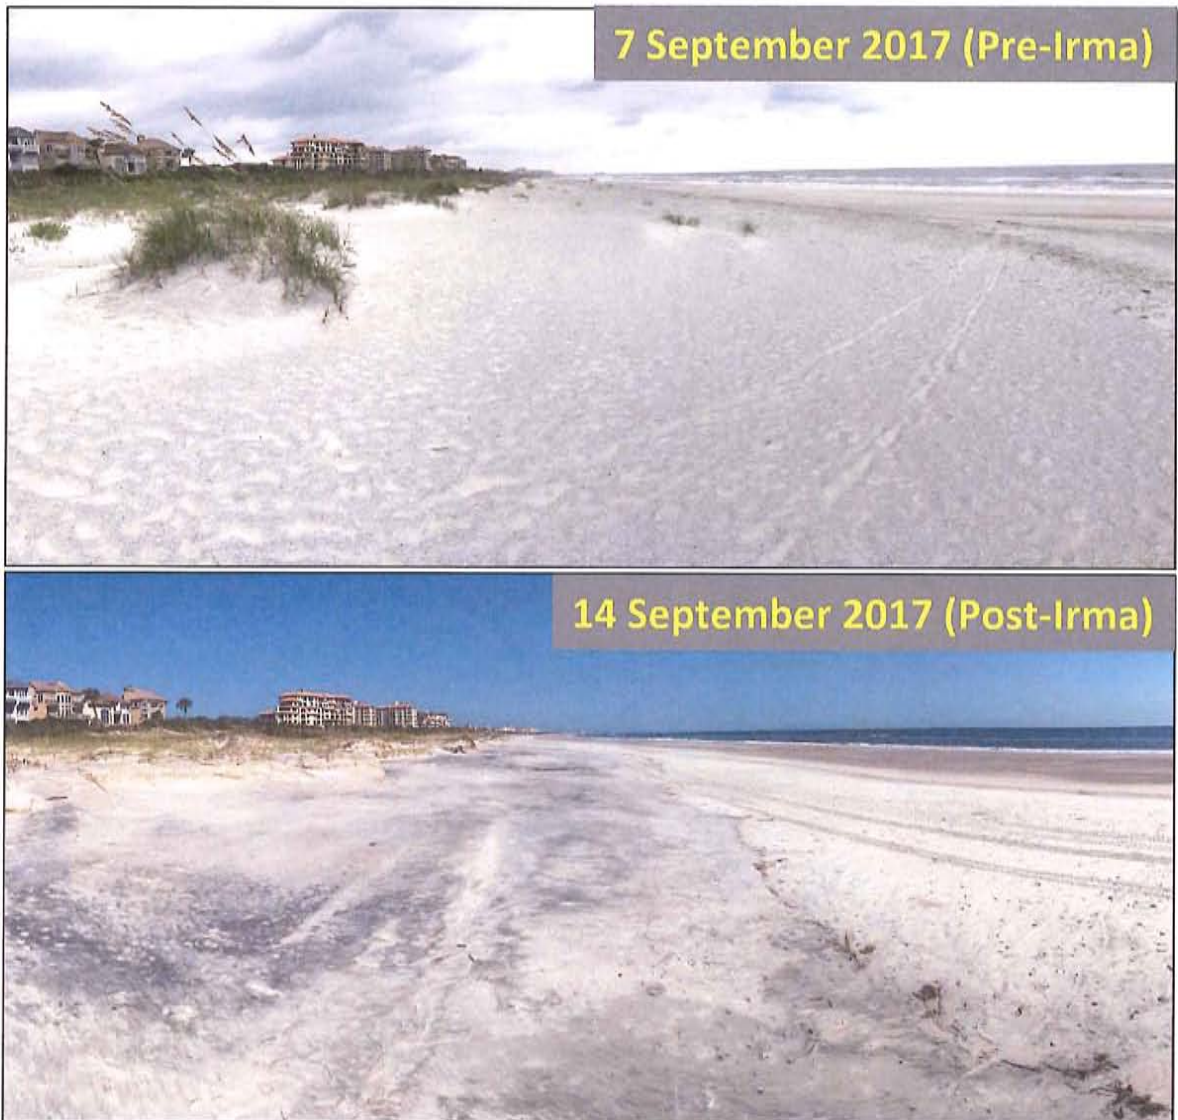
Figure 3.8: Pre- and post-Hurricane Irma SAISSP shoreline at the South County Access on Amelia Island, looking northward toward FDEP survey monument R-70. Note the deflation of the beach berm, evidenced by the loss of pioneer vegetation

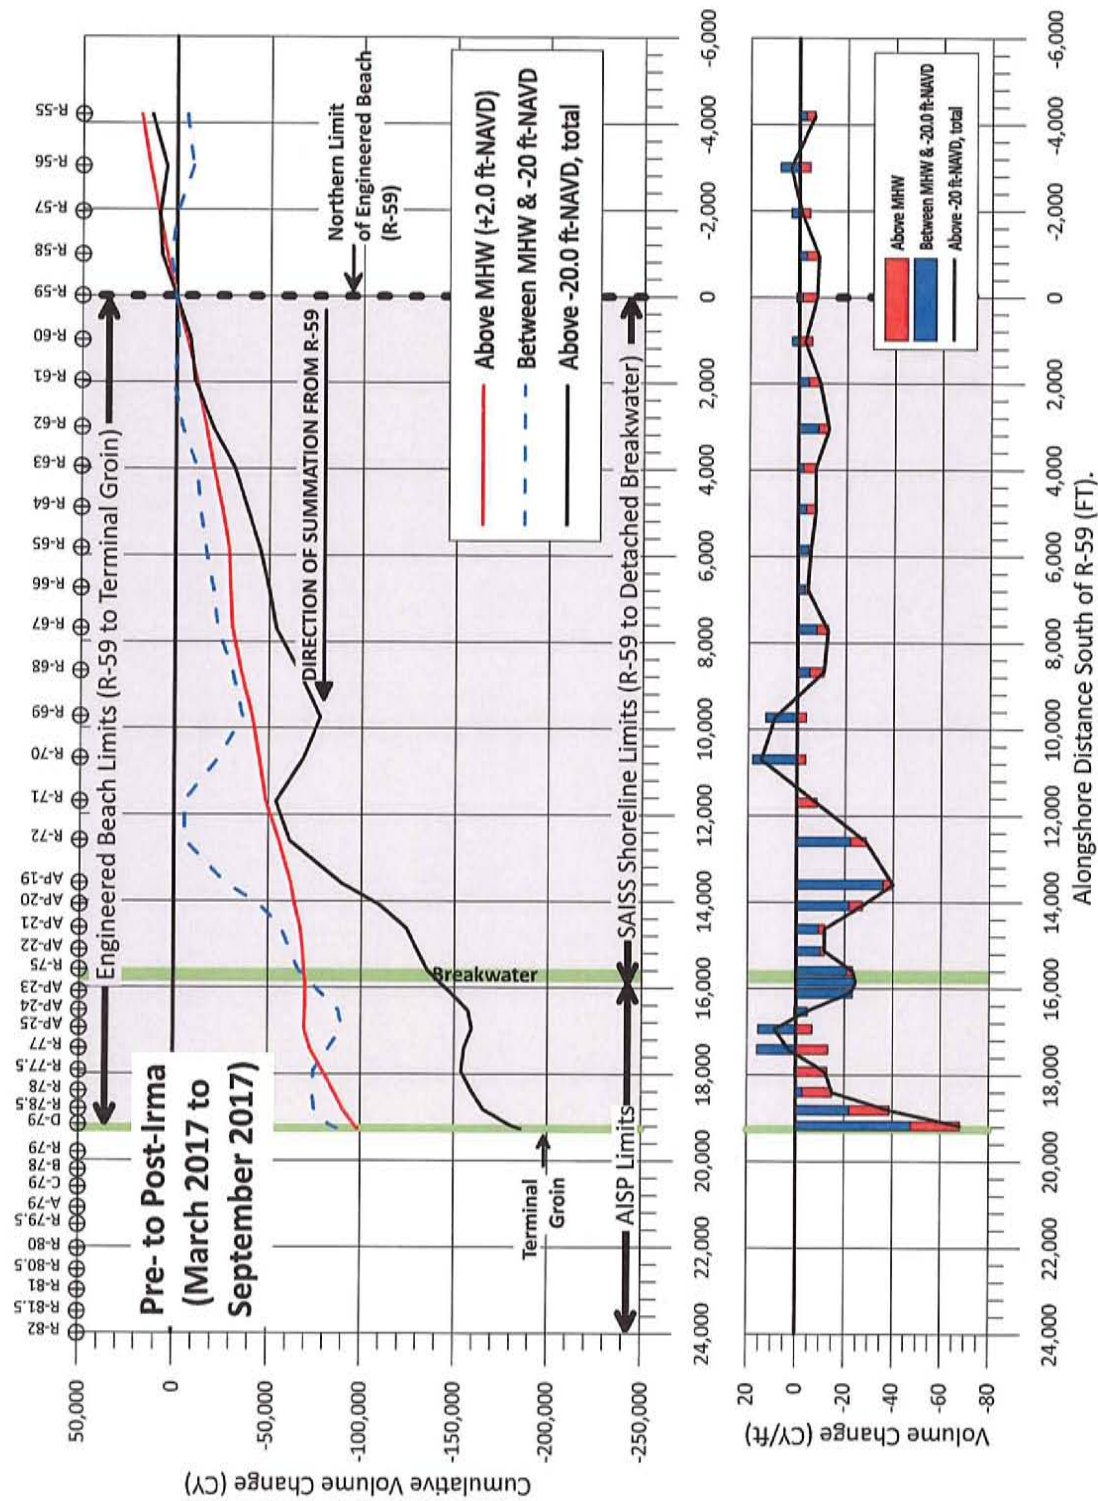
Figure 3.9 depicts the changes in beach sand volume over the March 2017 to September 2017 survey period. The lower frame of **Figure 3.9** depicts the volume density change, in bar chart form, at each transect in cubic yards per foot (cy/ft). The stacked bars indicate the changes above the MHWL (red bars) and between the MHWL and -20 ft-NAVD (blue bars). The upper frame of **Figure 3.9** plots the cumulative volume changes along the project shoreline beginning at R-59. This plot illustrates the different areas of shoreline behavior as evidenced by changes in slope of the cumulative curves. Each curve represents the total volume change measured to the specified elevation. Individual volume changes computed between profile transects are tabulated in **Appendix B**. Based upon inspection of the historical beach profiles in this area, the closure depth is taken to be -20 ft-NAVD.

Figure 3.9: Pre- to Post-Irma beach volume changes (March 2017 to September 2017), South Amelia Island, FL.

Between March 2017 (pre-Irma) and September 2017 (post-Irma), the entire surveyed shoreline (R-55 to the terminal Groin) lost approximately -117,100 cy above the MHWL and an additional -81,900 cy below the MHWL to -20 ft-NAVD for a net loss of -199,000 cy. Above the MHWL, 29 of the 31 profiles surveyed experienced a net loss. Above -20 ft-NAVD, 23 of the 29⁵ profiles surveyed experienced a net loss.

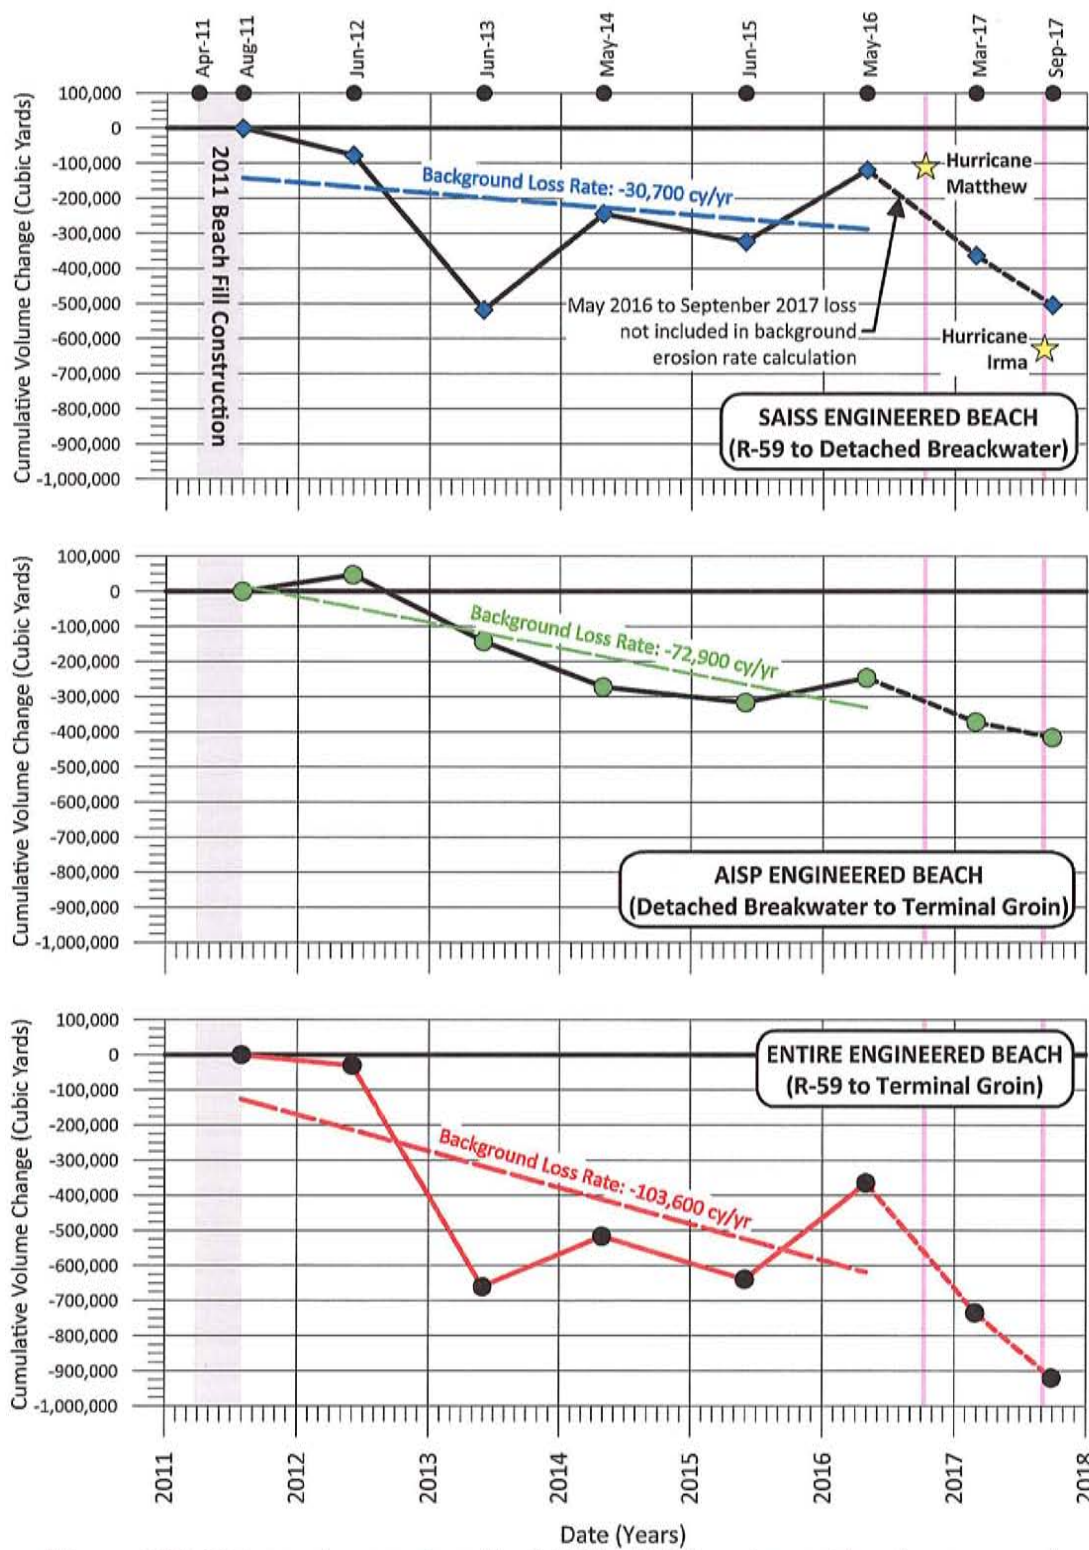
Figure 3.10: Volume changes along the SAISSA/AISP engineered beaches measured above -20 ft-NAVD since completion of the 2011 Beach Renourishment Project.
