SUMMER BEACH  
PARCEL  
NASSAU COUNTY  
PREPARED FOR  
FORUM CAPITAL PARTNERS

FINAL DEVELOPMENT  
SIGNAGE PAGE

## FINAL DEVELOPMENT PLAN

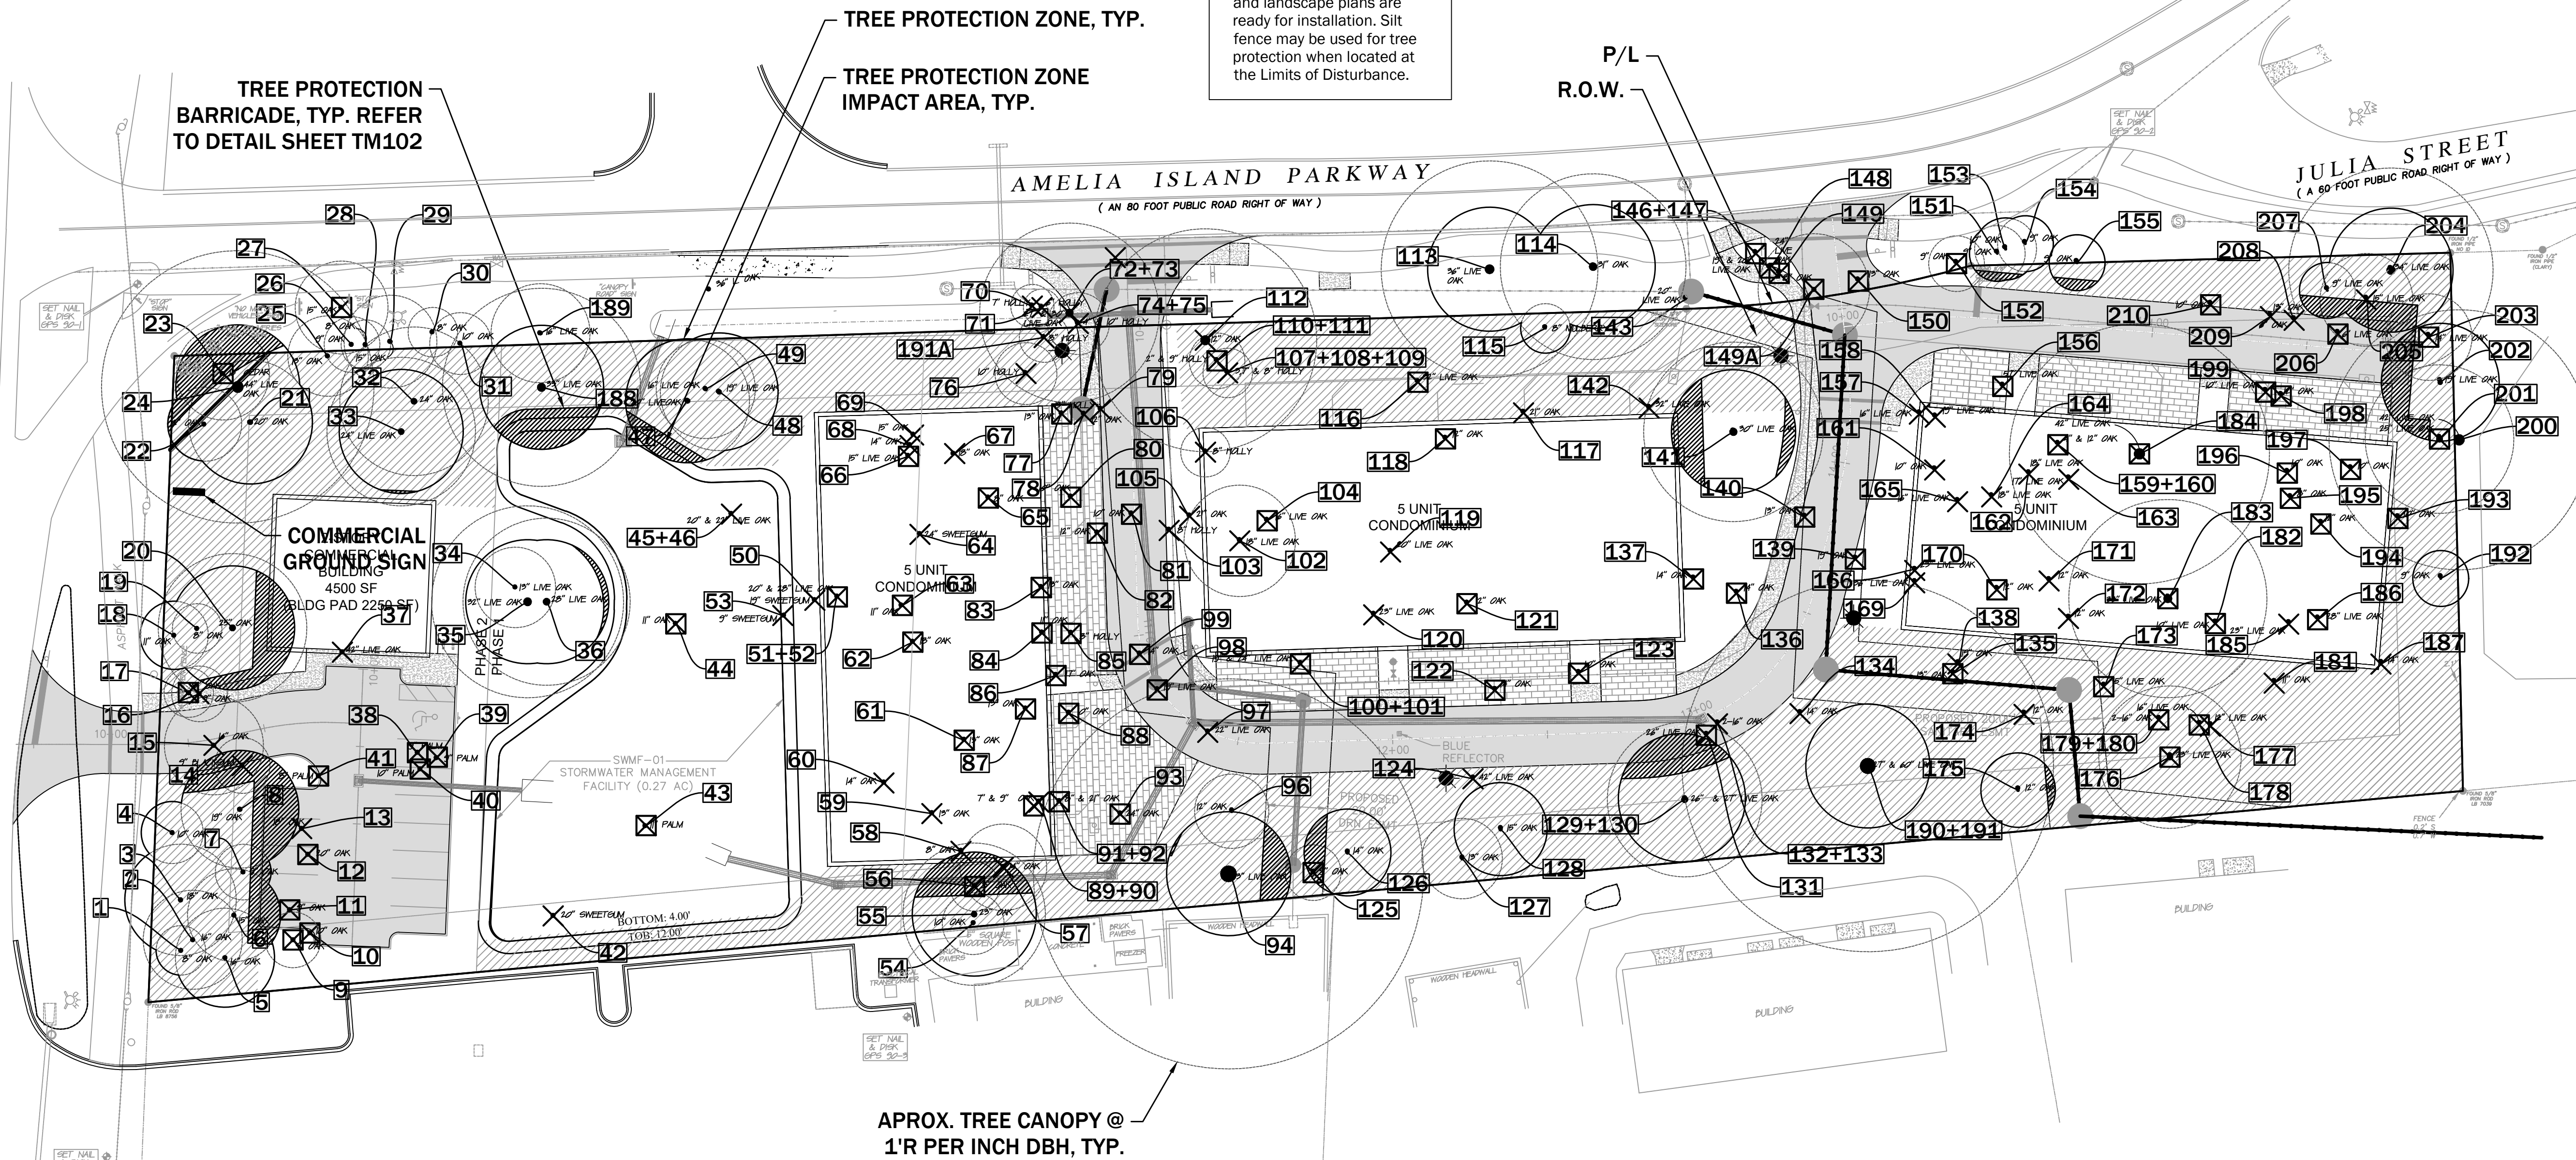
APROX. TREE CANOPY @  
1'R PER INCH DBH, TYP.

Recommended Action and final inches and mitigation amounts are based on the proposed site plan.

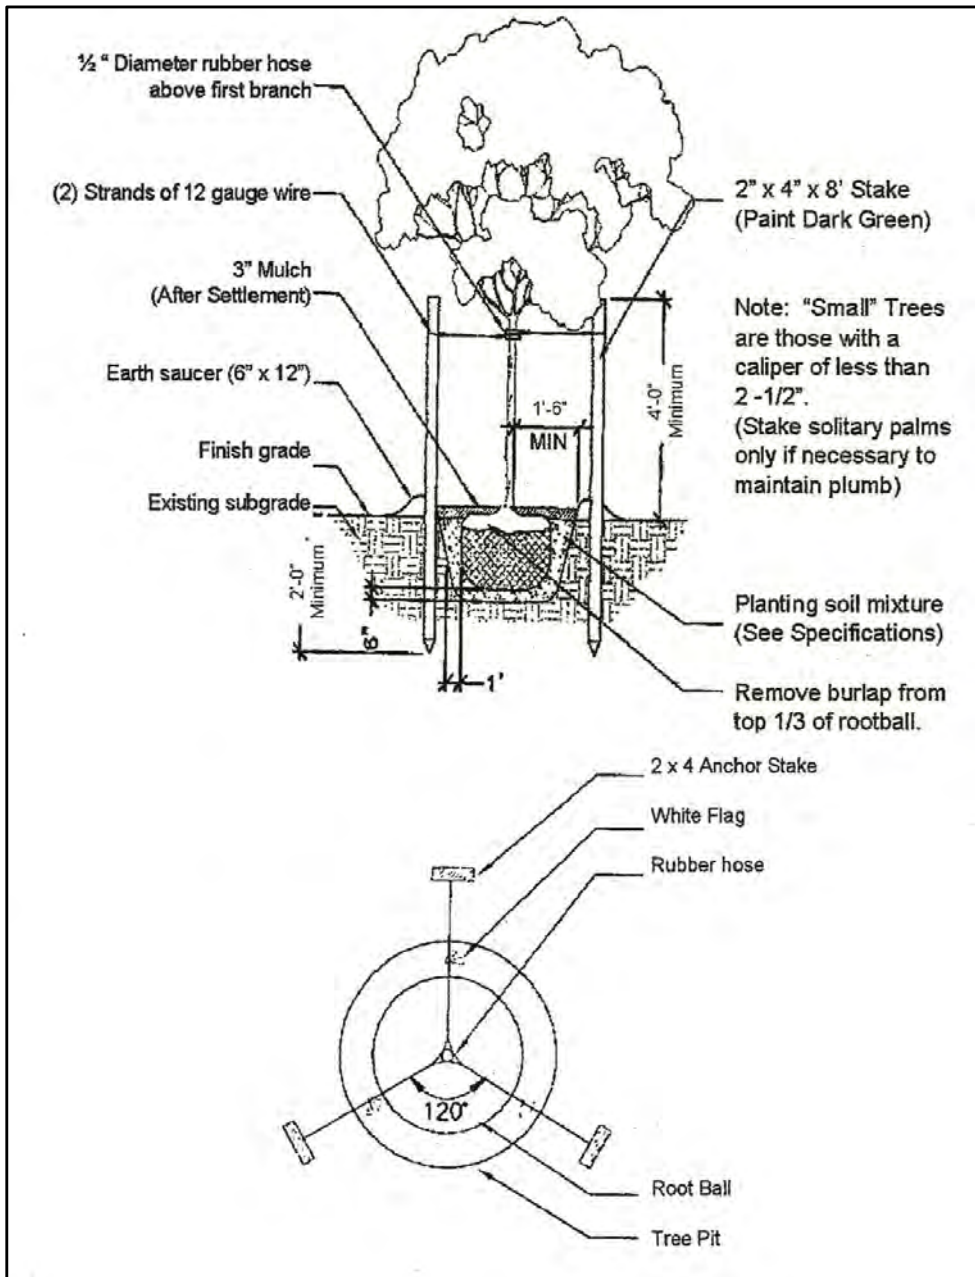
All trees planted shall be staked or guyed for a period of at least six (6) months in accordance with this detail.

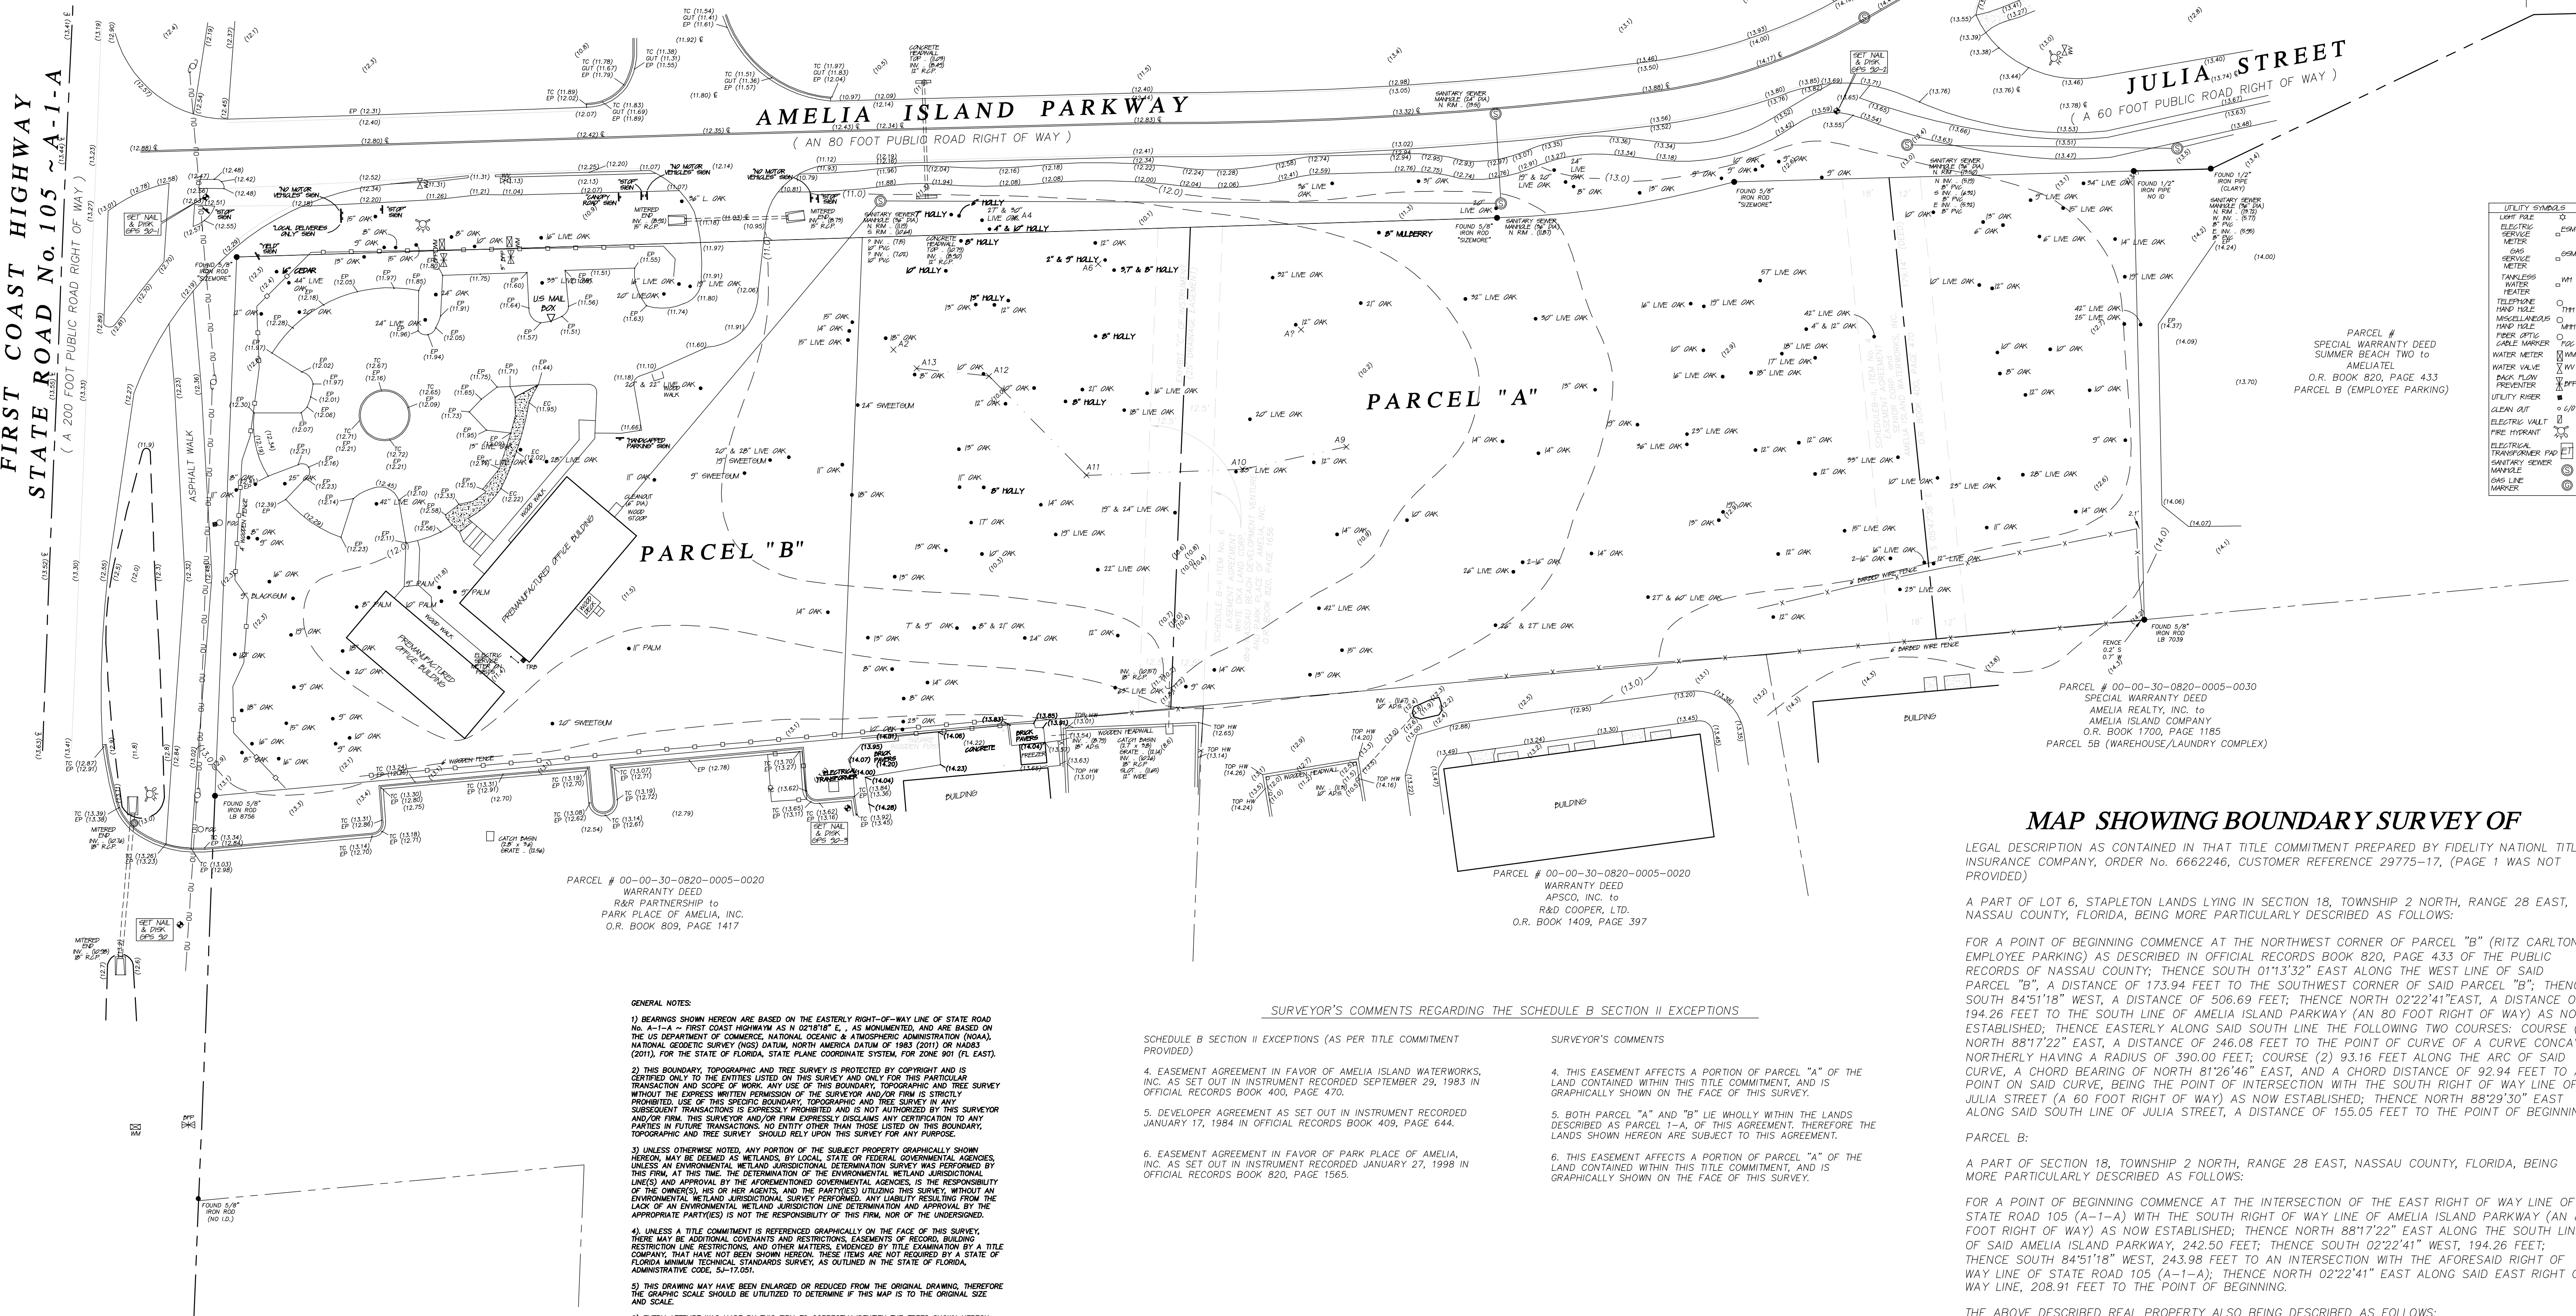
JOB No. 49685  
F.B. 520, PAGE 21 (BENCH RUN)  
COMPOSITE MAP OF THREE (3)  
DIFFERENT SURVEYS
